# Drone Roof Inspection Report

**1234 Example Ln, Fort Worth, TX 76100**

Visual condition assessment | Report # SR-0000-SAMPLE

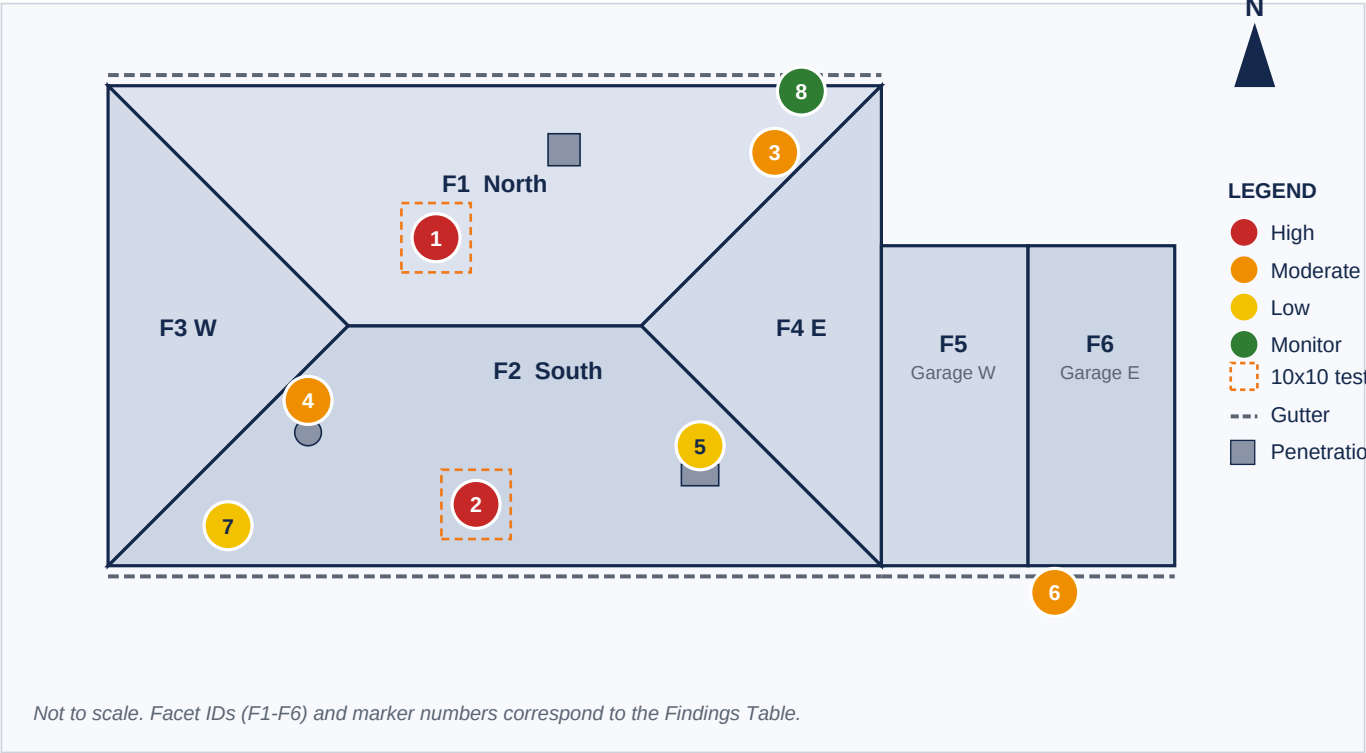
# Roof Diagram & Findings

**Overall condition:** Storm-related damage observed. Hail impact density on the North (F1) and South (F2) slopes exceeds the common 8-hits-per-test-square threshold used by many roofers and adjusters when evaluating slope replacement. Final determination rests with the roofing contractor and insurance adjuster.

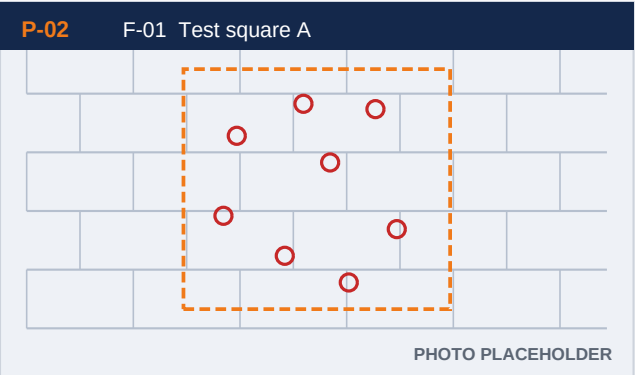
| ID | Location / Slope | Issue | Severity | Recommendation |
|---|---|---|---|---|
| F-01 | F1 North slope, center (test sq. A) | Hail impacts: 9 functional hits per 10x10 test square; bruised mat, fractured granule surface | High | Recommend full slope replacement evaluation by roofer; document for insurance claim |

P-02. F1 North slope test square A: 9 functional hail hits circled. Captured 25 ft above roof surface.

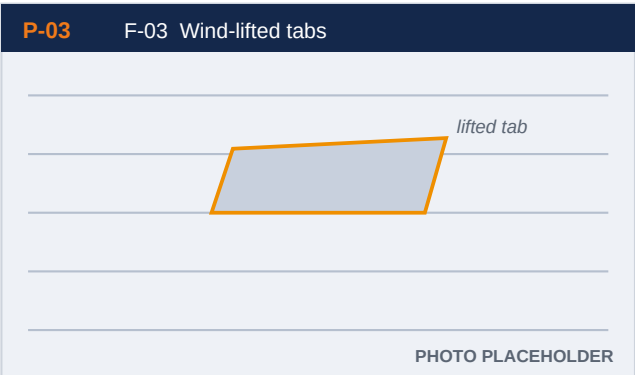
| ID | Location / Slope | Issue | Severity | Recommendation |
|---|---|---|---|---|
| F-03 | F1 North slope, NE hip | Wind-lifted / creased shingle tabs (approx. 6 tabs), broken seal strips | Moderate | Re-seal or replace affected tabs; inspect adjacent courses for unsealing |

P-03. F1 NE hip: creased and lifted tabs with broken seal strips. Zoom 4x, 40 ft AGL.

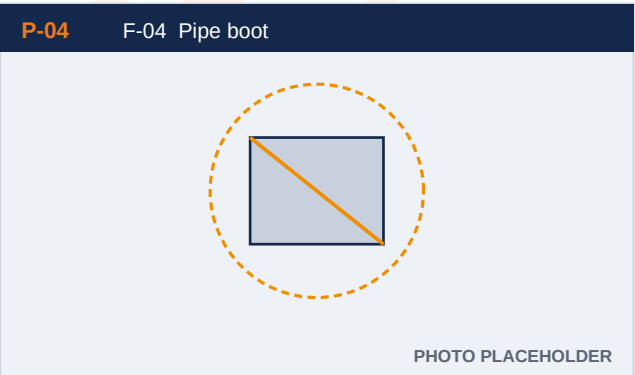
| ID | Location / Slope | Issue | Severity | Recommendation |
|---|---|---|---|---|
| F-04 | F2 South slope, plumbing vent | Pipe boot collar cracked; possible water entry point | Moderate | Replace pipe boot; check decking/attic for moisture |

P-04. F2 South slope plumbing vent: cracked boot collar. Close-up, 20 ft above surface.

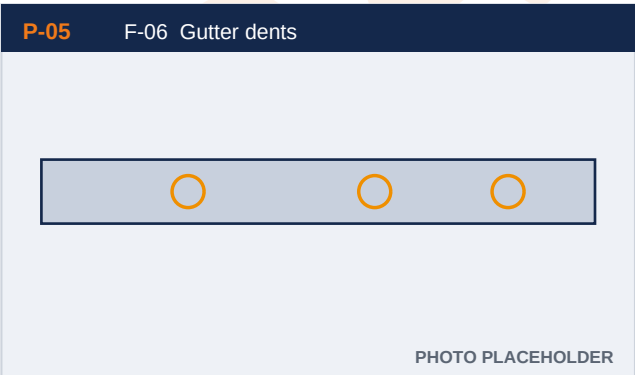
| ID | Location / Slope | Issue | Severity | Recommendation |
|---|---|---|---|---|
| F-06 | Garage F5/F6, south eave gutter | Gutter dents (3 locations) and one loose hanger | Moderate | Repair/replace gutter run; re-secure hangers |

P-05. South garage eave gutter: three impact dents and one loose hanger. Oblique, 30 ft AGL.

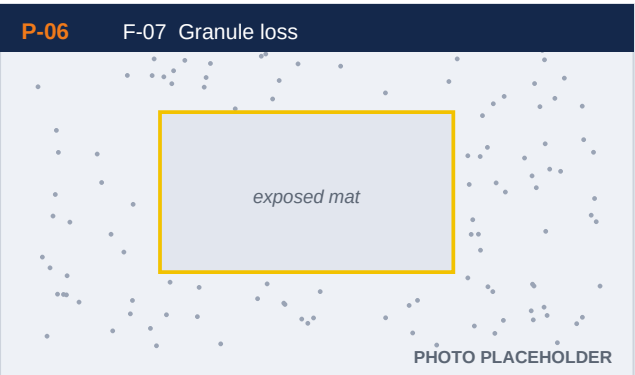
| ID | Location / Slope | Issue | Severity | Recommendation |
|---|---|---|---|---|
| F-07 | F3 West slope, lower courses | Granule loss with localized exposed mat (~2 sq ft) | Low | Spot repair; monitor for accelerated aging |

P-06. F3 West slope lower courses: granule loss with localized exposed mat (~2 sq ft).
